## CONTAMINATION SCREENING EVALUATION REPORT

Florida Department of Transportation

North Sarasota Multimodal Connector PD&E Study

Date: July 2022

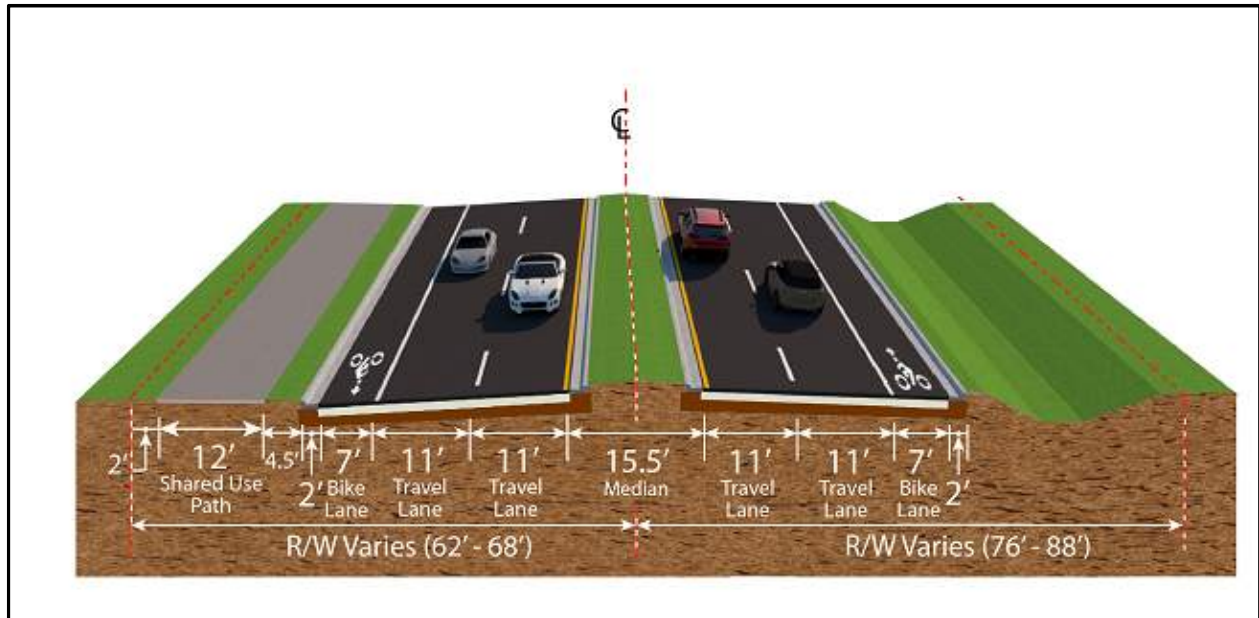
**Figure 1-2: Four-lane At-Grade Typical Section**

The Overpass Road section is comprised of four 11-foot travel lanes, two in each direction, two seven-foot bicycle lanes, one in each direction, and a 12-foot shared use path on the north side of the roadway. The proposed roadway is divided by a 15.5-foot grassed median (**Figure 1-2**). The design speed is 40 mph. The total right-of-way width required to accommodate the proposed overpass along this segment varies from 138 feet to 156 feet.

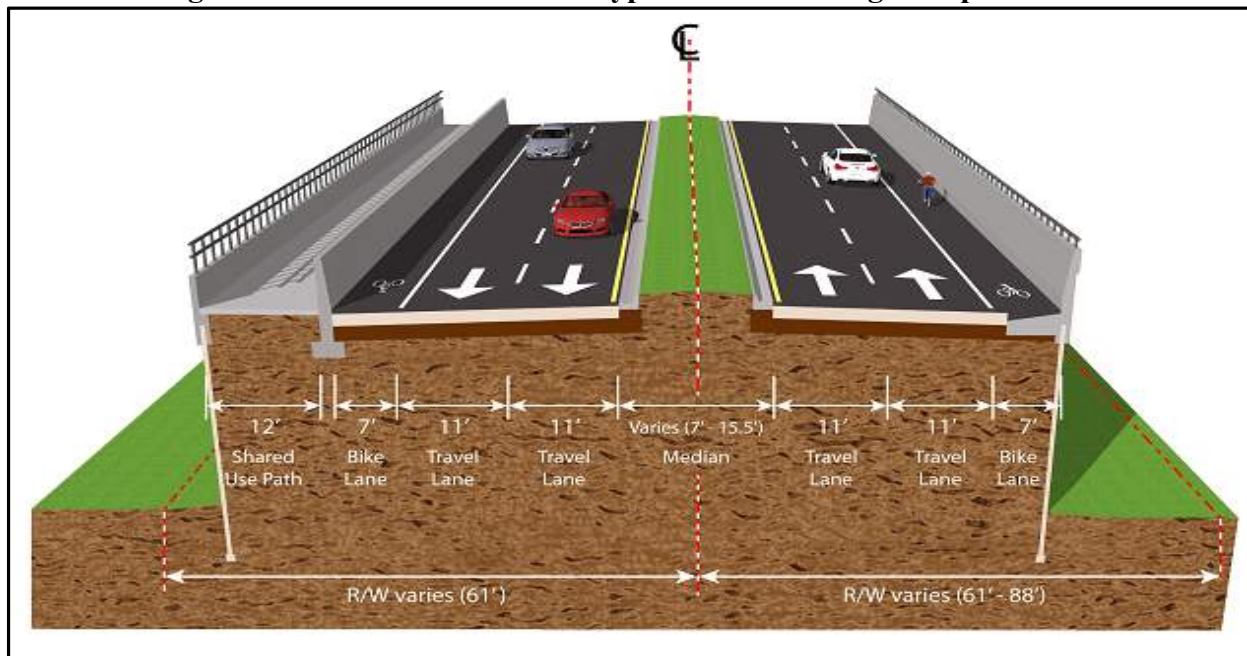
**Figure 1-3: Four-lane Elevated Typical Section along Overpass Road**

The proposed 15-foot shared-use path on Cattlemen Road and the 12-foot shared-use path on the Overpass Road will be located along the proposed elevated overpass roadway and will provide a connection between the Nathan Benderson Park and the Lakewood Ranch Development. The existing alignment of the unpaved path and paved Bill Robinson Trail traversing the perimeter of the lake will be modified, as needed, to maintain the 15-foot paved trail.

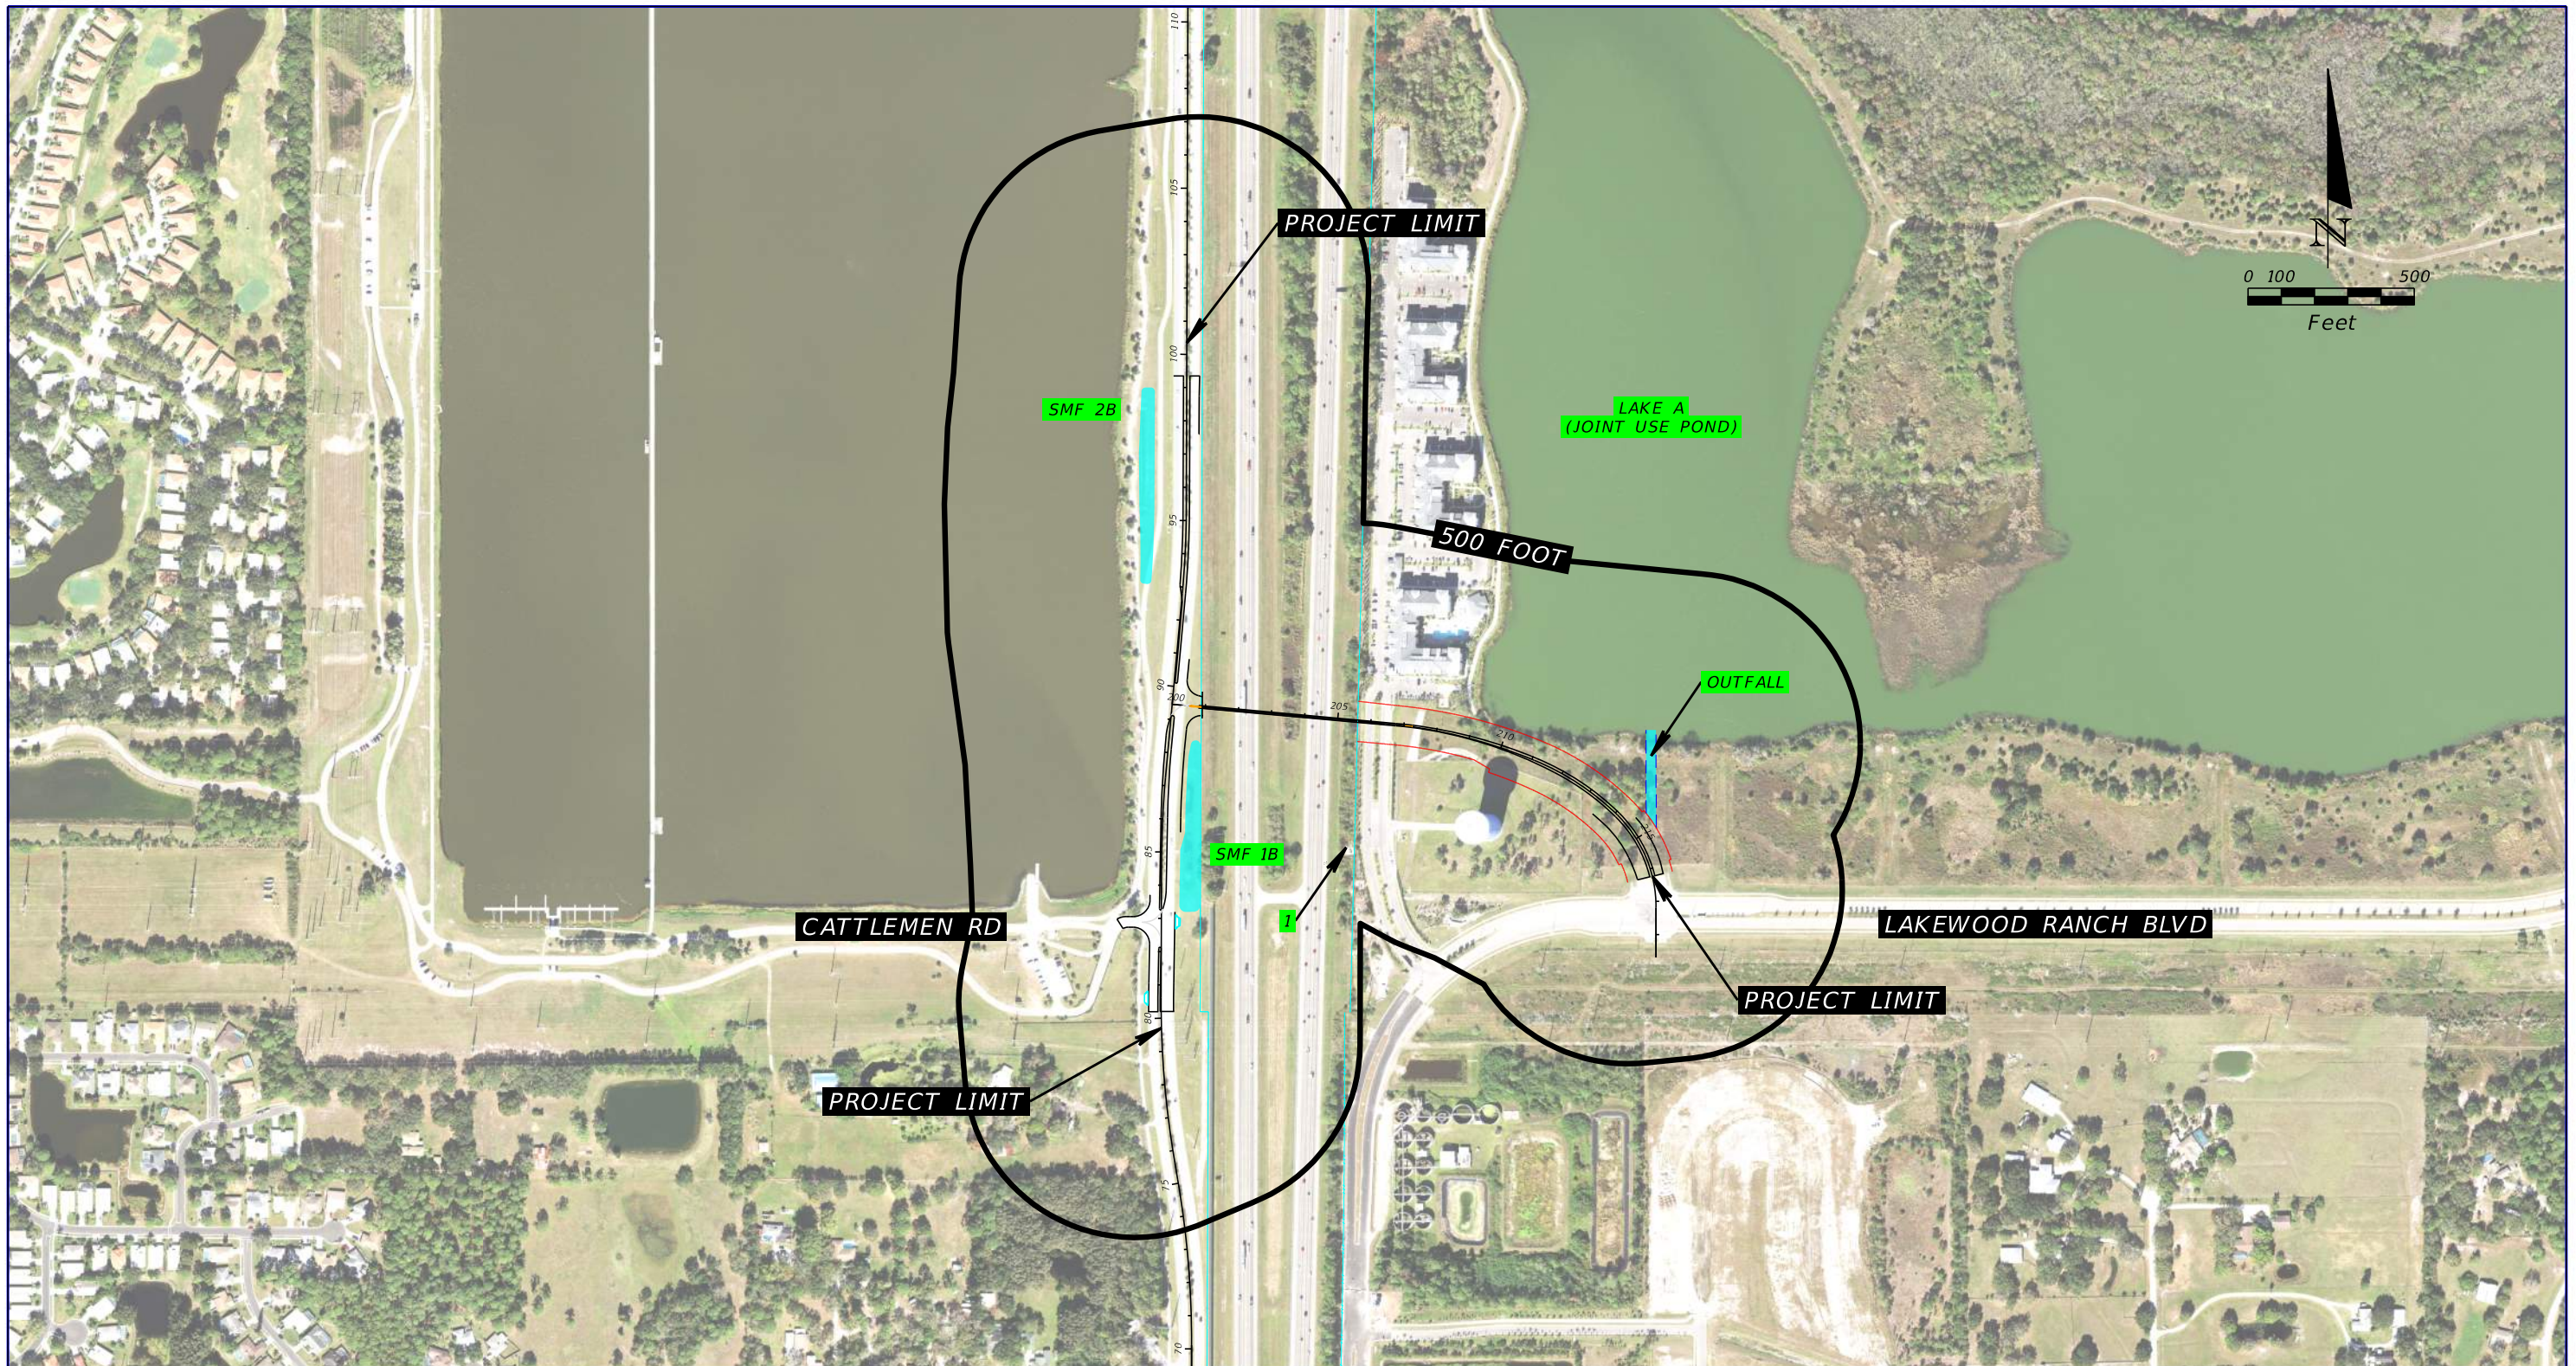
POND ALTERNATIVE AND POTENTIAL CONTAMINATION SITES

NOTE: SITE 2 IS NOT DEPICTED ON THIS MAP. SEE SHEETS B-4 AND C-1.

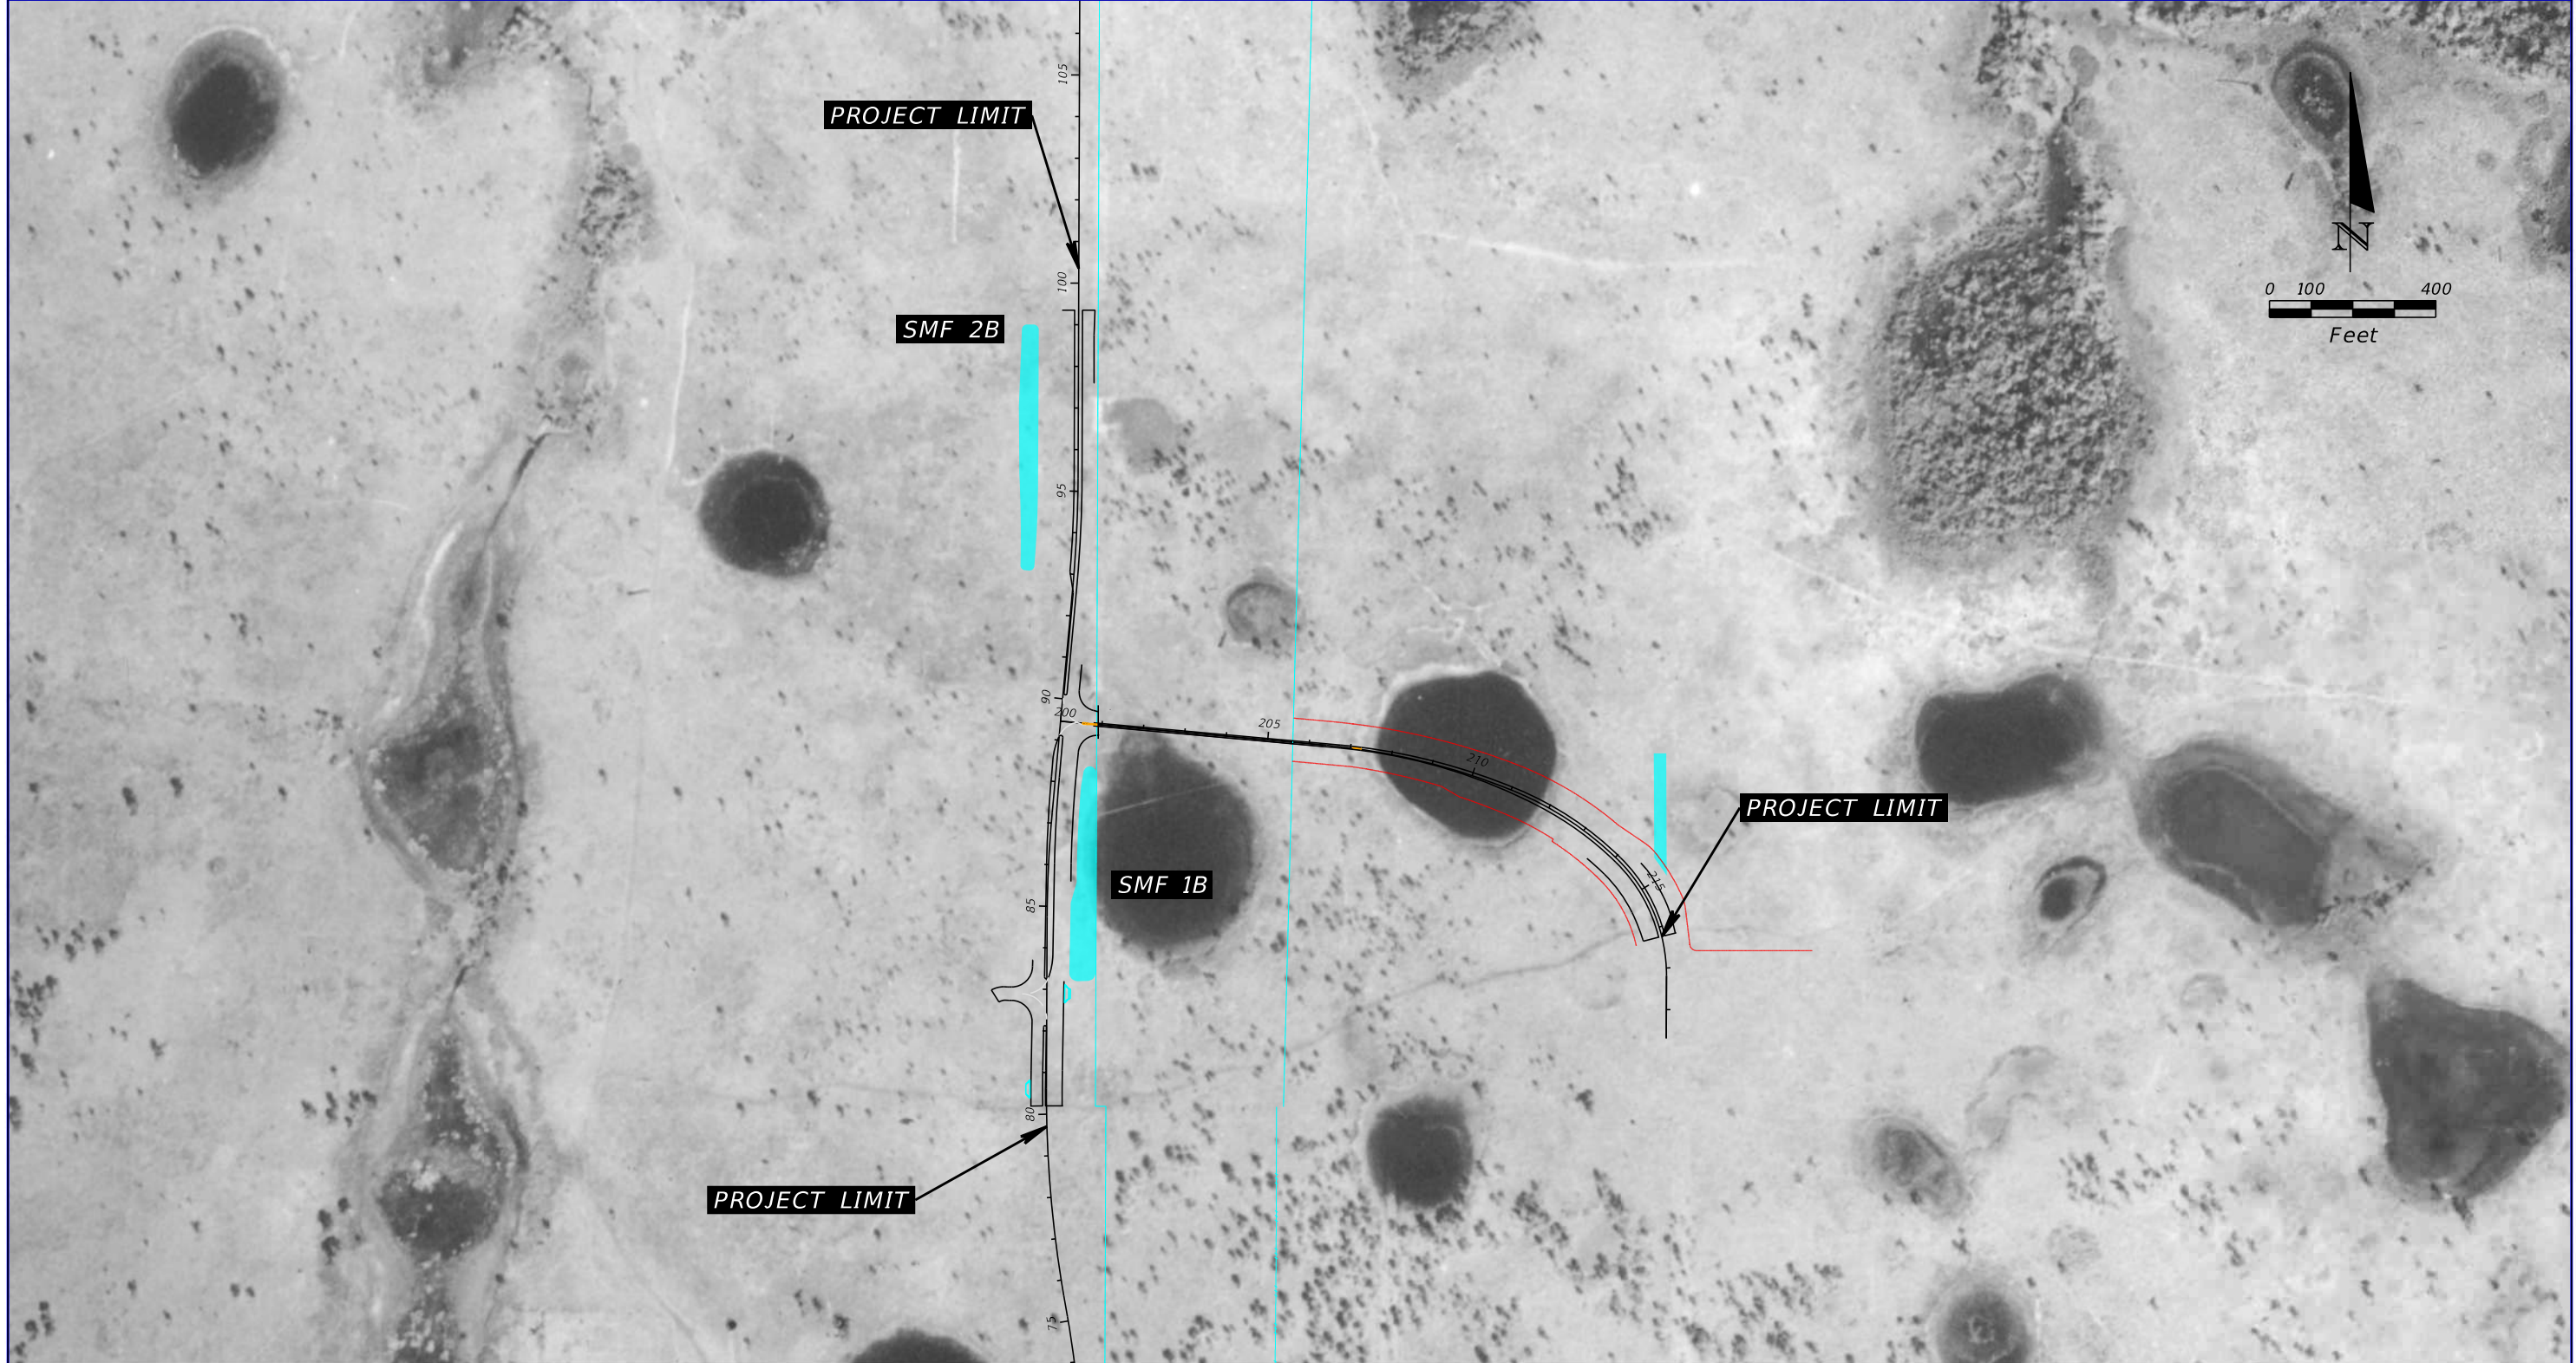
1948 HISTORICAL AERIAL PHOTOGRAPH

TABLE 3: AERIAL PHOTOGRAPH REVIEW - MAINLINE		
Year	Comment	Contamination Concerns
1948-1969	Generally, the land within and surrounding the project is comprised of undeveloped land including pasture, low-lying wet areas, and woodlands.	No concerns noted
1977	Mining activities are visible throughout the majority of the project, presumably associated with SMR Aggregates/Quality Aggregates, Inc (Site 2).	Mined land (SMR Aggregates/Quality Aggregates, Inc) (Site 2)
1985	I-75 is added in the central portion of the project. Lakewood Ranch Boulevard is added to the east of I-75. It appears that mining operations in the vicinity of the project have ceased.	No new concerns noted
1994-1995	No noteworthy changes noted.	No new concerns noted
1998	A water tower is added in the vicinity of the project to the east of I-75.	No new concerns noted
2004	A recreation/picnic area is added within proposed ROW to the north of the Lakewood Ranch Boulevard project limit.	No new concerns noted

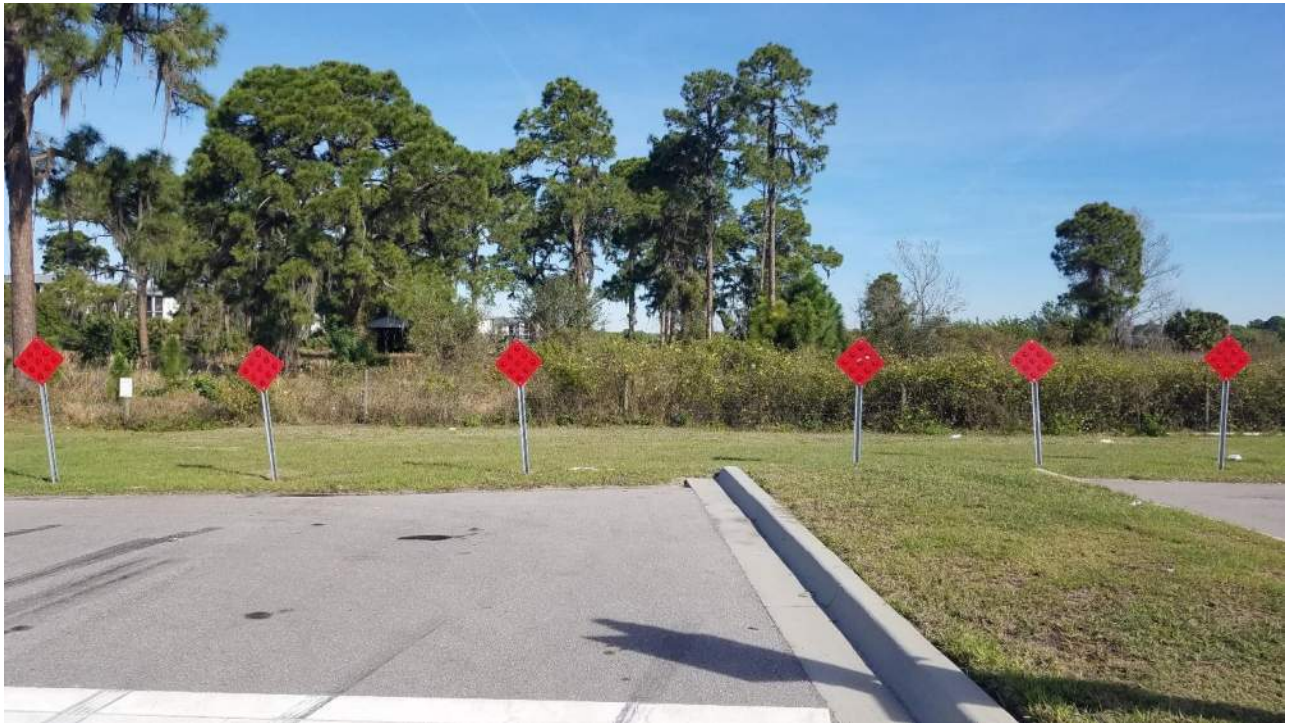
Lakewood Ranch Boulevard looking north along proposed ROW

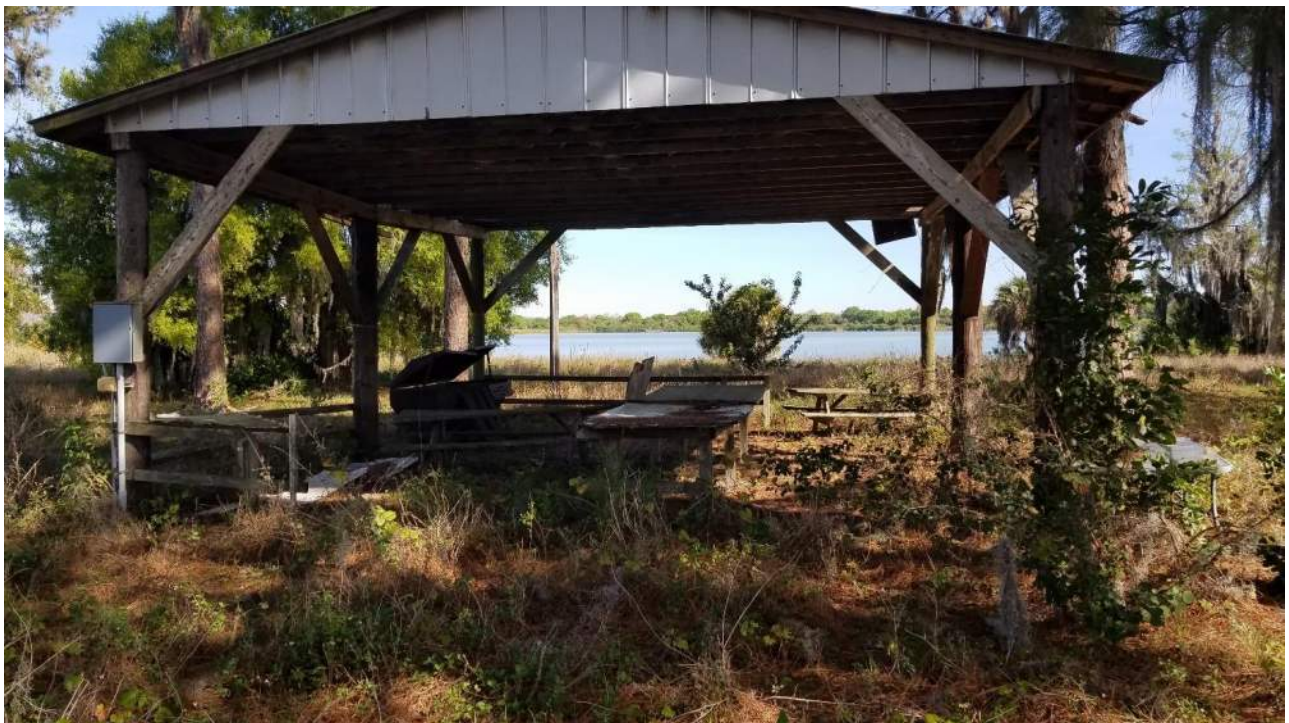
Picnic area within proposed ROW located approximately 250 feet north of the Lakewood Ranch Boulevard project limit

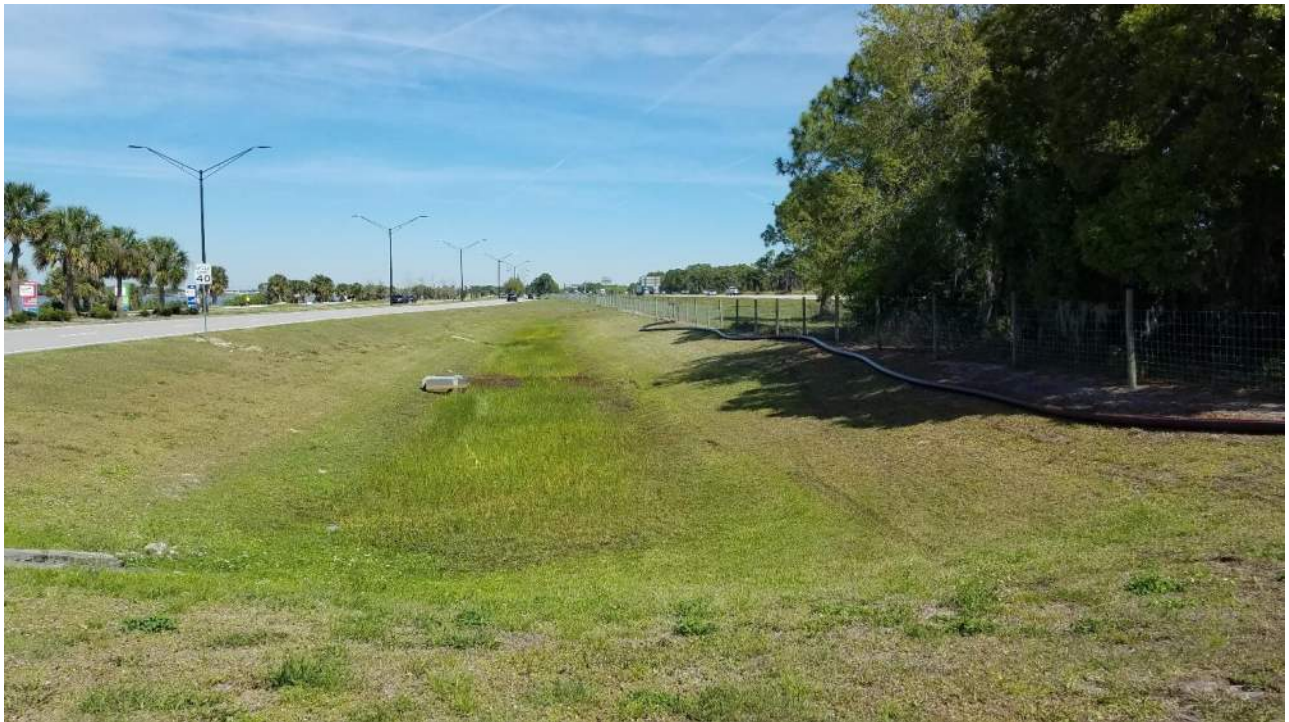
TABLE 6: PROJECT IMPACTS - PONDS		
Pond Site	Risk Rating	Comments
SMF 1B	No	<p><b>Current Land Use:</b> During the site reconnaissance, this pond site was observed as Cattlemen Road ROW. Surrounding areas include I-75 to the east, Cattlemen Road roadway/ROW to the north, south, and west.</p> <p><b>Contamination Concern(s):</b></p> <p><b>Site #2: Formerly Mined Land (SMR Aggregates/Quality Aggregates, Inc), located within the boundaries of SMF 1B</b> – Mining operations were identified during the review of topographic maps and aerial photography dated 1977 (<b>CSER Appendix B, Sheet B-4</b>). No structures associated with the mine were noted within 500 feet of the project during the review of aerial photography and topographic maps. Location information included in the storage tank files indicate that all petroleum tanks associated with the mining operation were located beyond 500 feet from this pond site. Aggregate mining does not typically utilize hazardous materials or generate hazardous waste as a byproduct. Due to the benign nature of the former aggregate mining activities, this site is considered a low risk to this pond site.</p> <p><b>Risk rating:</b> No contamination concerns were identified, therefore pond SMF 1B is assigned a risk rating of No.</p>

Southern area of SMF 1B looking north

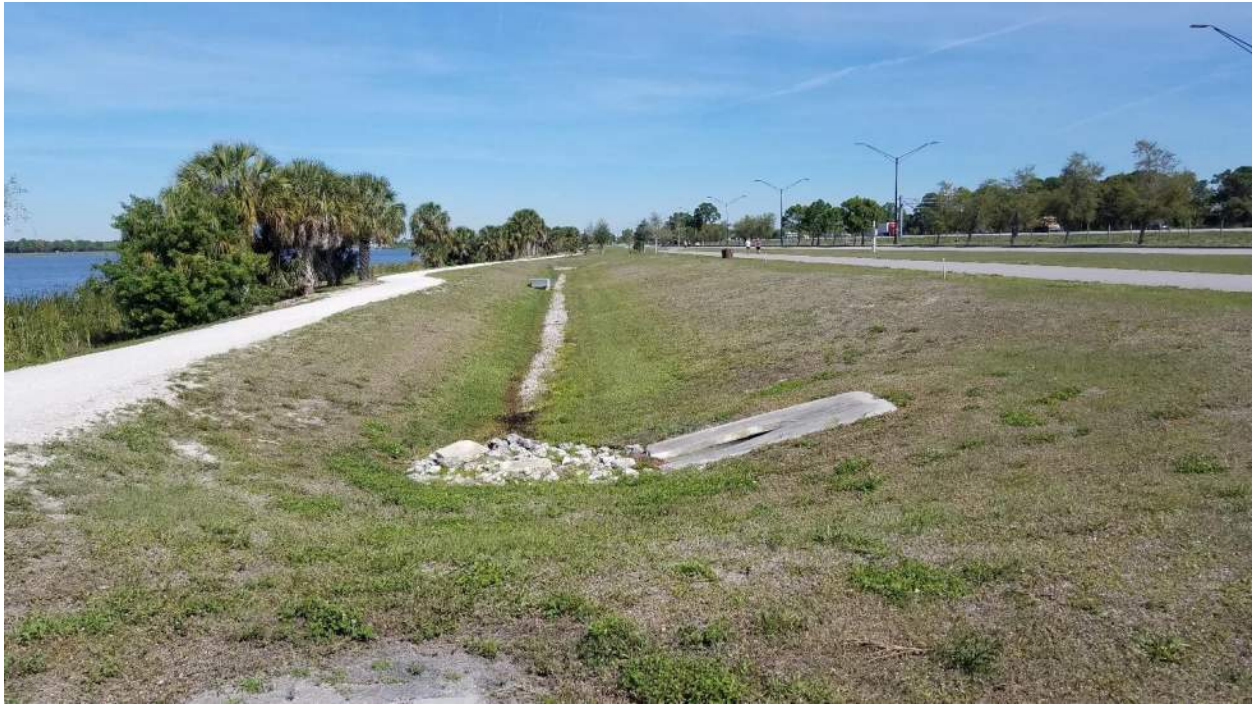
SMF 2B	No	<p><b>Current Land Use:</b> During the site reconnaissance, this pond site was observed as a dry retention pond. Surrounding areas include Cattlemen Road roadway/ROW to the east, and Nathan Benderson Park to the north, south, and west.</p> <p><b>Contamination Concern(s):</b></p> <p><b>Site #2: Formerly Mined Land (SMR Aggregates/Quality Aggregates, Inc), located within the boundaries of SMF 2B</b> – Mining operations were identified during the review of topographic maps and aerial photography dated 1977 (<b>CSER Appendix B, Sheet B-4</b>). No structures associated with the mine were noted within 500 feet of the project during the review of aerial photography and topographic maps. Location information included in the storage tank files indicate that all petroleum tanks associated with the mining operation were located beyond 500 feet from this pond site. Aggregate mining does not typically utilize hazardous materials or generate hazardous waste as a byproduct. Due to the benign nature of the former aggregate mining activities, this site is considered a low risk to this pond site.</p> <p><b>Risk rating:</b> No contamination concerns were identified, therefore Pond SMF 2B is assigned a risk rating of No.</p>

Southern area of SMF 2B looking north
